# **KURRU ARCHEOLOGICAL PROJECT (QSAP-13)**

## **2016-2017 Field Report**

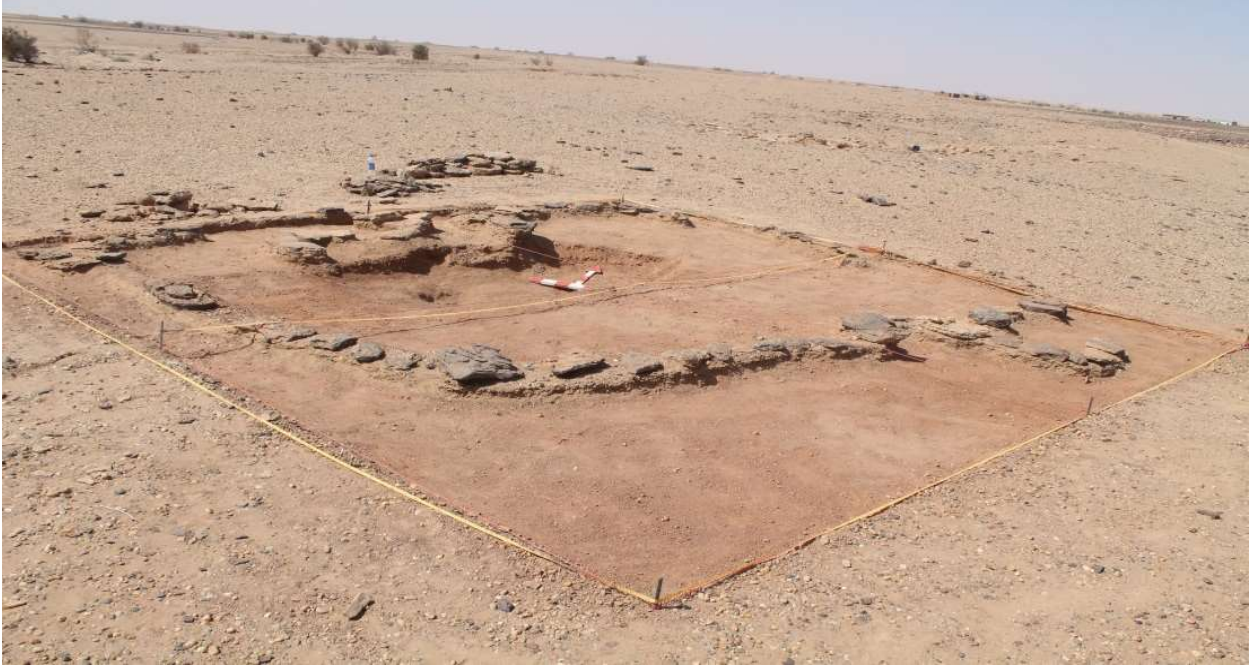
**(fig 1)**

1. Few surface finds of stone artifacts of various phases from various localities, but of no concentration.
2. Stone foundation c.100m west of the site, looked at first to be a burial, but clearance showed foundation of small hut. The few pot sheds revealed were not diagnostic (fig 1).

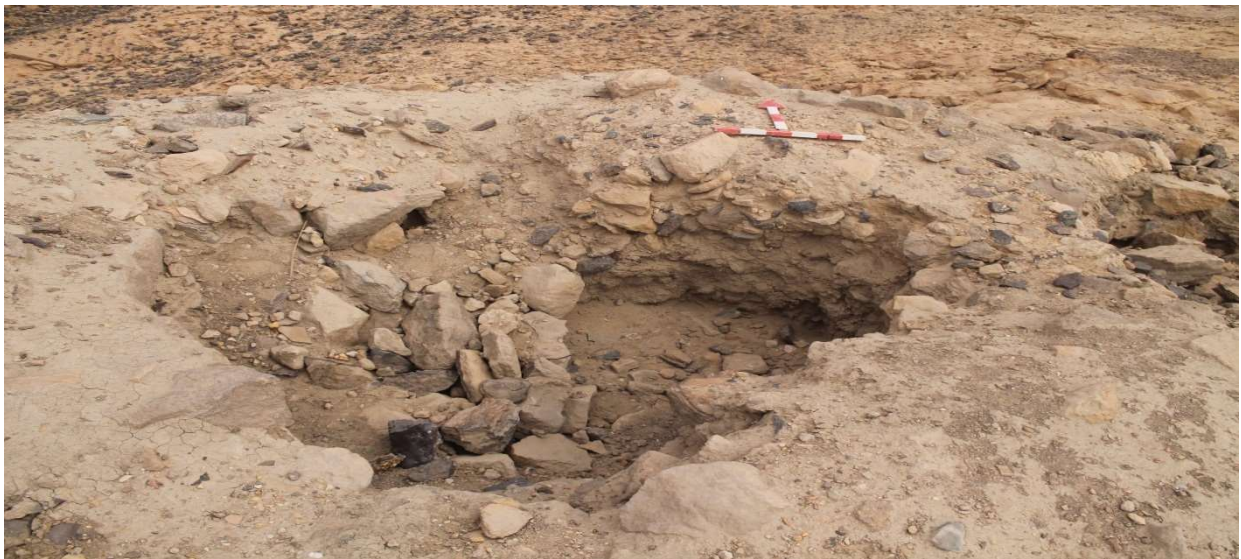
**(fig 2)**

3. On top of a high sandstone hill. 2.5 m south of the site, a collapsed watching tower built of sandstone, currently 2.5 m high was located. Close by few disturbed graves, some were plundered. The potsherds collected call for Christian and Islamic types (fig 2).

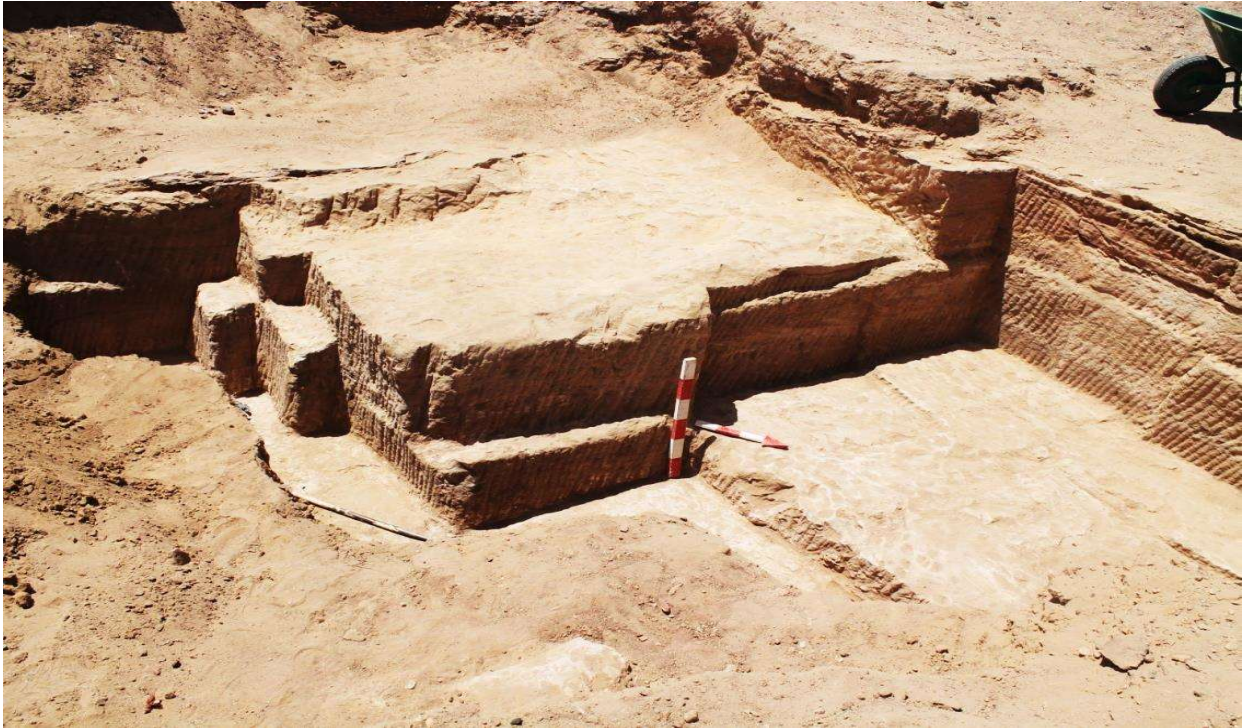
(fig 3)

4. Two Kushite queries were located in sandstone formations. Both were cleared showing clear signs of the ways they were measured and cut (fig 3). The first is 200 m. west of the site while the second is 3 Km north east at EL-Date c.500m west of the right bank of the Nile.

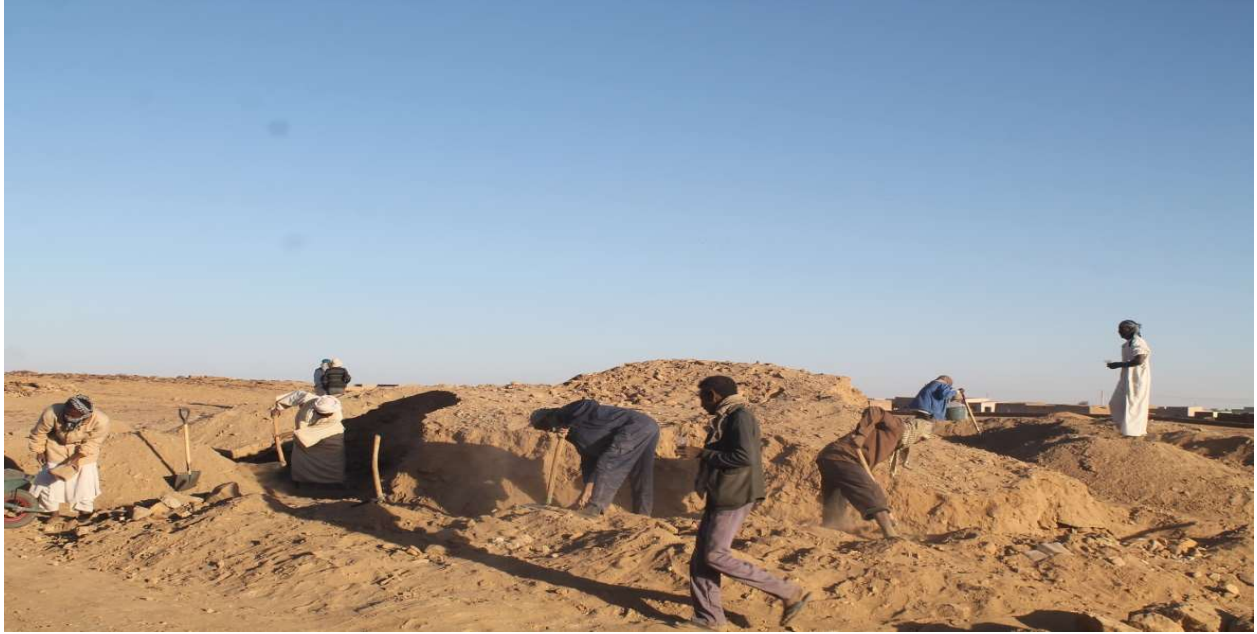
**(fig 4)**

The fifteen spoil heaps in the middle field left behind from last season were cleared. Some of these were very large measuring over 5m×3m and over 2m high (fig 4).

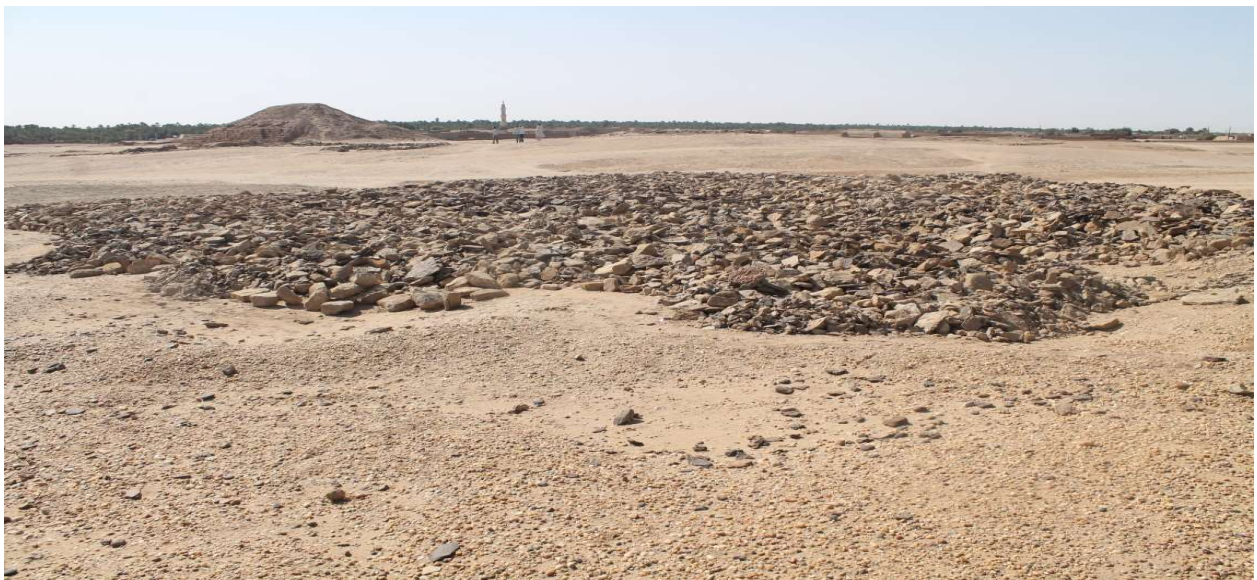
**(fig 5)**

It has been previously tested and proven which heap belongs to which burial. We started by loosening the soil to separate the broken and fragmented sandstone blocks from the rubble. The stones we taken to a point distant from the burials, and there arranged in a mastaba form, for any future reuse (fig 5).

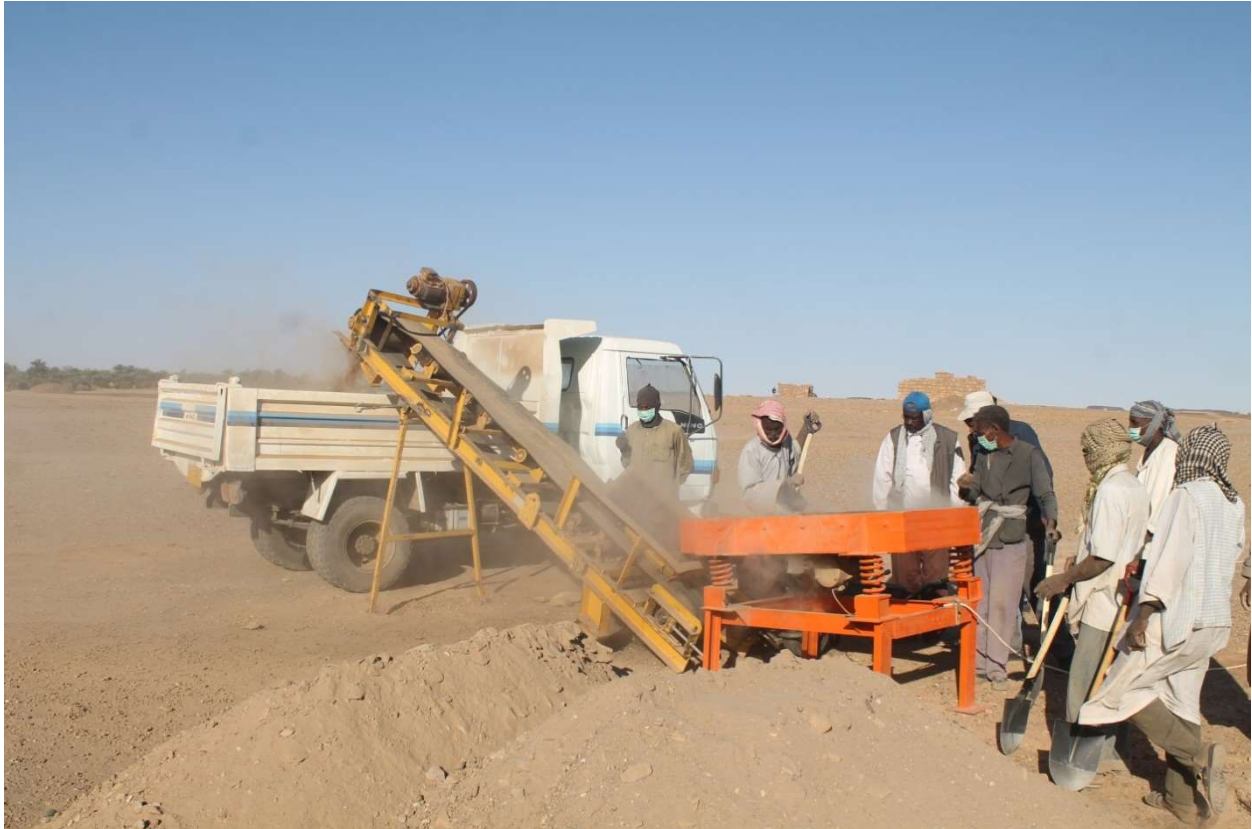
**(fig 6)**

Then sifted the soil using a mechanical sifter. Wheelbarrows were take the soil from where the heap was to a point distant from the burials to where the sifter was (fig 6).

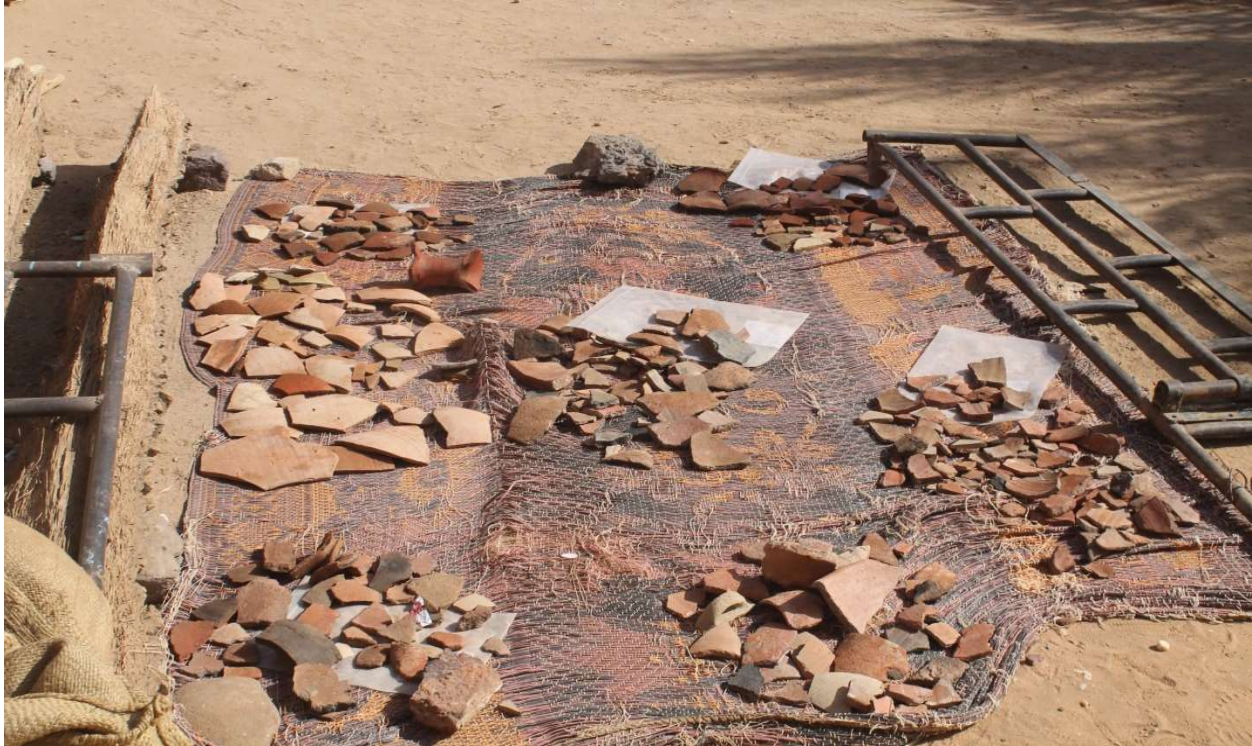
(fig 7)

potsherds and other finds were picked from the sifter and the rest of the soil was to be transferred by a truck to a point outside the buffer zone. Over 13000 potsherd and reasonable number of small finds including shawabties, figurines, fragments of fiancés and alabaster pieces, were recovered (fig 7).

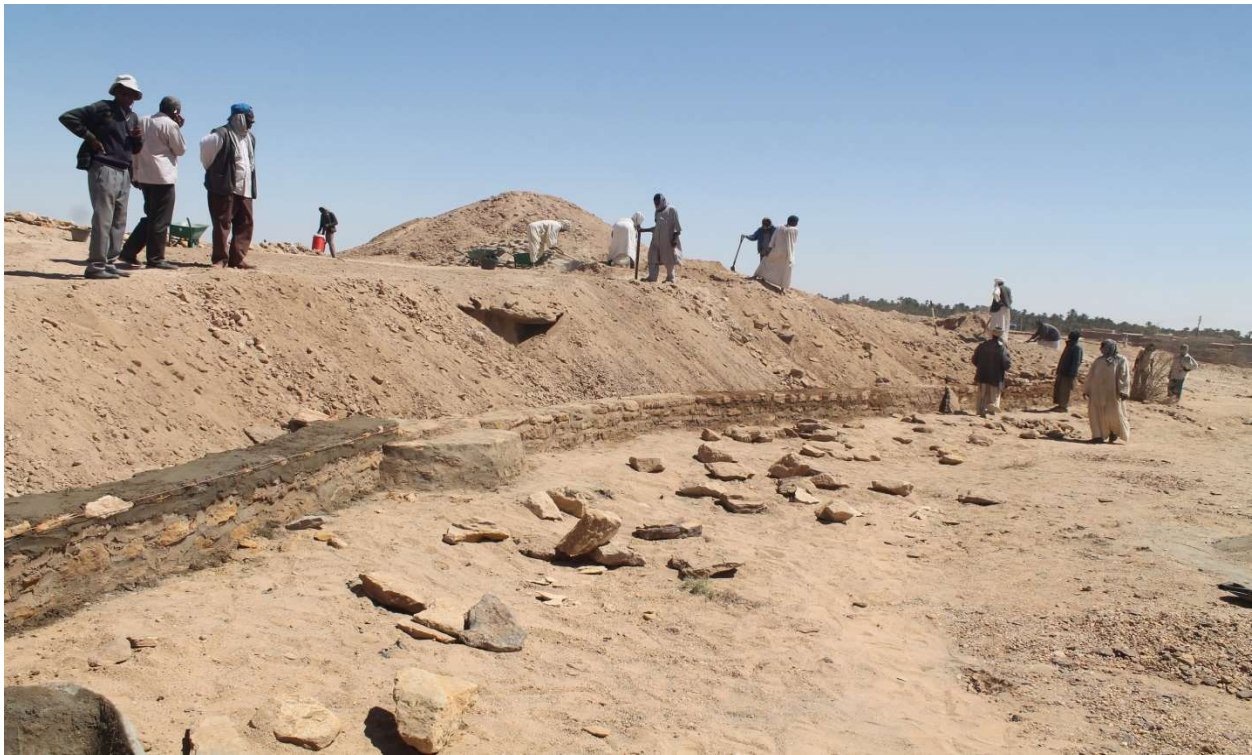
**(fig 8)**

For the last 100 years, since Reisner's work in the site, it remained unprotected and subjected to a century of continuous misuse causing partially irreplaceable damage to the antiquities. During those years, together man and nature have played a negative role in endangering its monuments. Some of the soft sandstone blocks were partly eroded or weathered when exposed to sunlight and wind. Cars and humans cut

their ways forming trails and truck tracks across the field. The flow of the two rain water channels intersecting the site drain water annually posing a threat to the antiquities on their sides. The southern tributary has eroded its northern and southern edges to reach a point 1-3m. of the royal pyramids, Ku-4 and Ku-18. A terrace of 33m. long to a height of 1.2m was built against the northern edge to protect Ku-18 of Shebtku (fig 8). The erosion in the southern edge of the channel approaching Ku-4 of queen Arti will be dealt with next season.

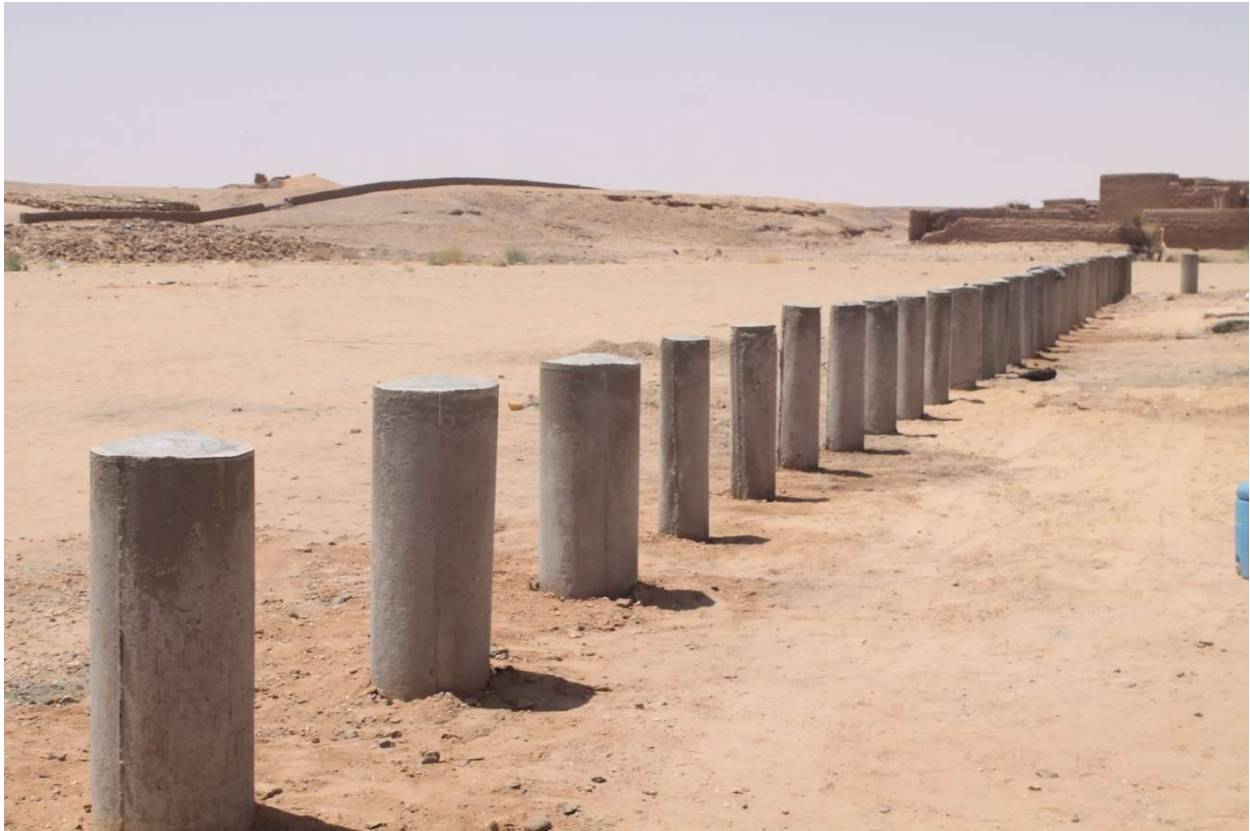
**(fig 9)**

In the second season, a mud wall was built to protect and mark the site and its buffer zone. Later some trucks broke through following their old track. To avoid such actions, we started constructing a line of cement pillars, each 25-30 cm. in diameter, 1 m. high and 1.2 m apart from each other's (fig 9). this will be continued to cover the rest of the site limits.

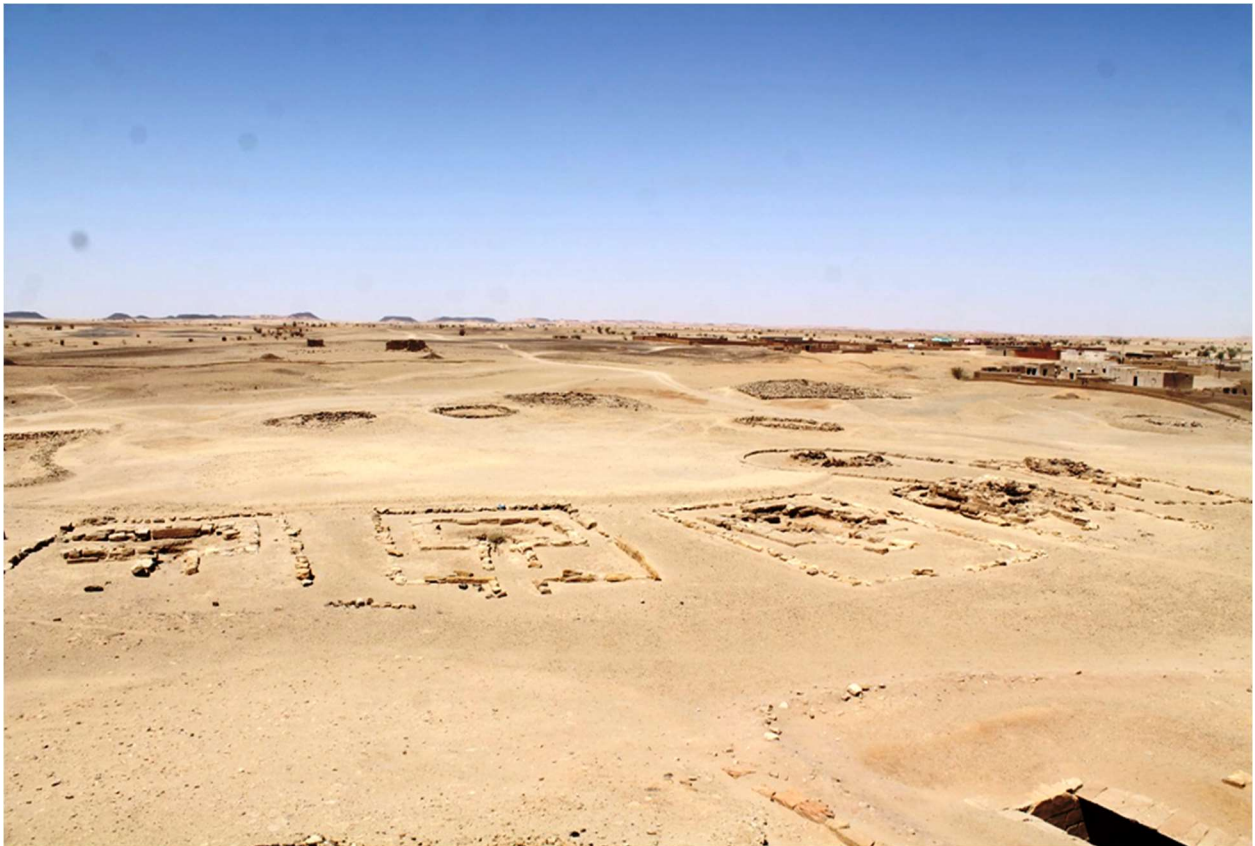
**(fig 10)**

After the spoil heaps were removed, the natural surface showed to be uneven. A plan was drawn to manage the rain water for the prevention of more damage. Shallow channels were scraped on the surface sloping the water either towards the northern wadi or the southern one, away from the antiquities (fig 10).

Yet the two wadis intersecting the site drain annually have stones and trash in their bottoms restricting the flow of the water. Part of this was cleared. The rest will be dealt with next season.

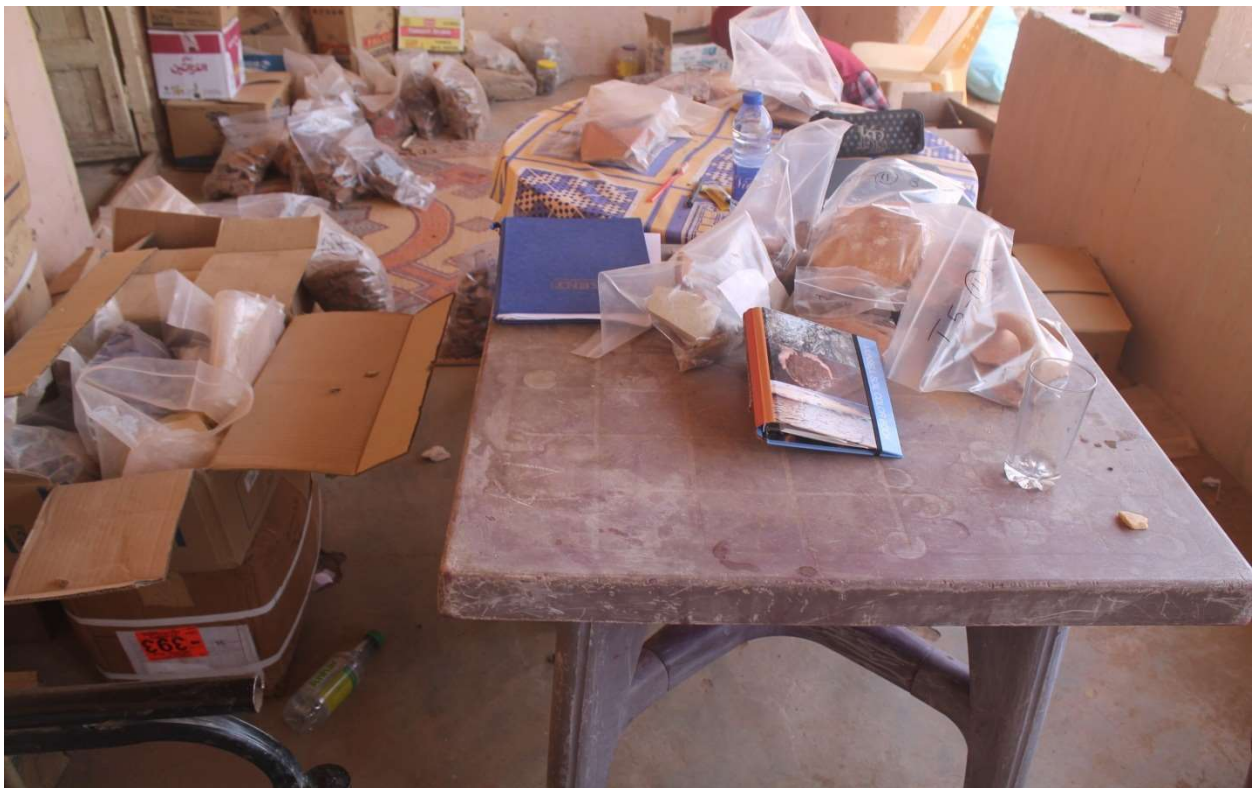
**(fig 13)**

The heap was removed in care (see above). The stone fragments, shaped or otherwise, count in thousands, were moved and arranged in a mastaba shape, laid in four groups for future reuse. the sifting revealed about 13000 fragments of potsherds together with fragments of shabtis, beads and bone (fig 13) waiting for detailed analyses.
